**United States Environmental Protection Agency  
Region V  
POLLUTION REPORT**

**Subject:** Initial and Final POLREP  
South Greenwood Site  
8849-59 South Greenwood Avenue, Chicago, IL  
Latitude: 41.734272  
Longitude: -87.597343

<b>POLREP No.:</b>	1	<b>Site #:</b>	B5KT
<b>Reporting Period:</b>	11/29/2007 - 12/26/2007	<b>D.O. #:</b>	
<b>Start Date:</b>	11/29/2007	<b>Response Authority:</b>	CERCLA
<b>Mob Date:</b>	11/29/2007	<b>Response Type:</b>	Time-Critical
<b>Completion Date:</b>	12/26/2007	<b>NPL Status:</b>	Non NPL
<b>CERCLIS ID #:</b>	ILN000510239	<b>Incident Category:</b>	Removal Action
<b>RCRIS ID #:</b>		<b>Contract #</b>

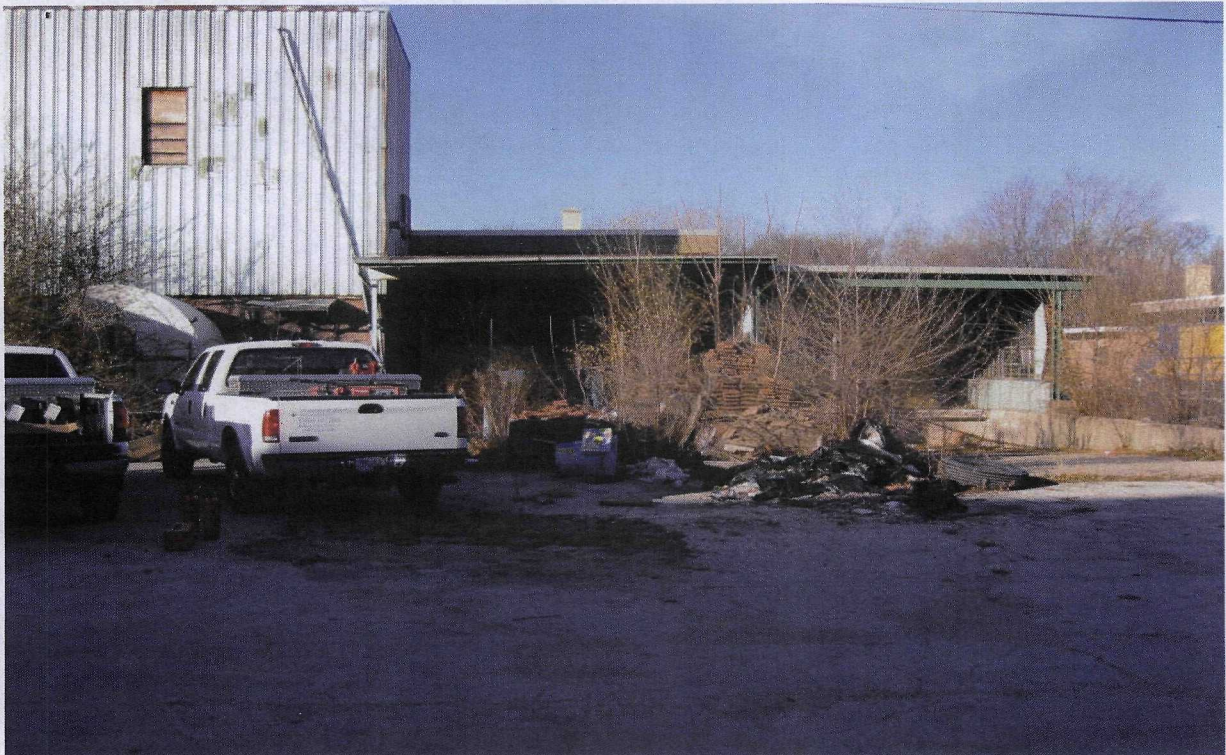
**Photo Number:** 1

**Subject:** Rear entrance and loading dock at 8848 South Greenwood Avenue

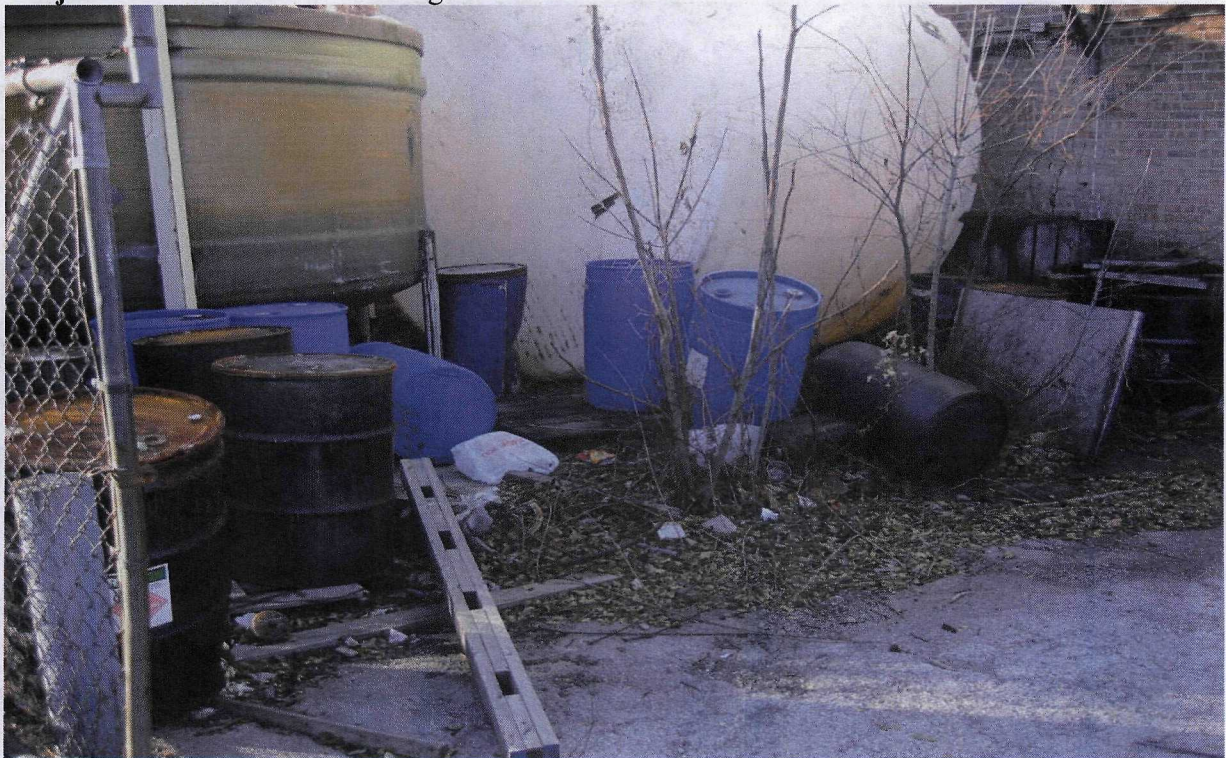
**Photo Number:** 2

**Subject:** Hazardous waste drums and empty storage tanks near rear entrance

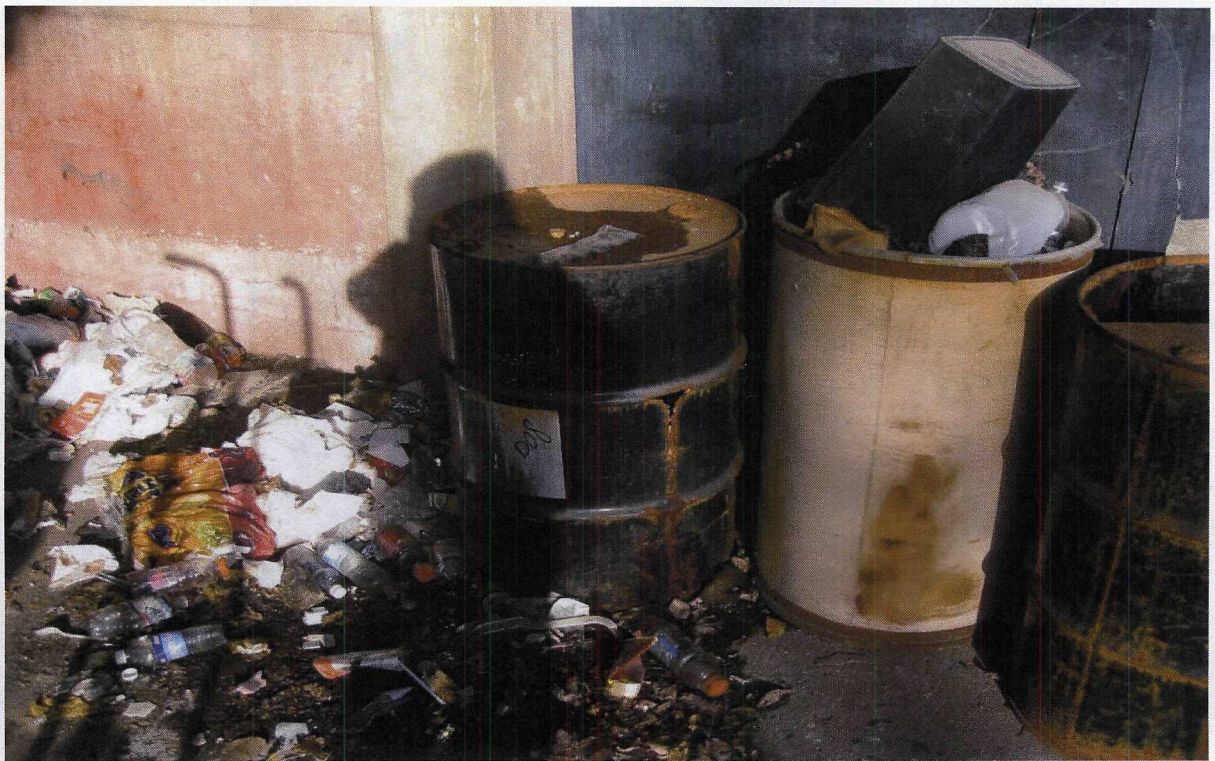
**Photo Number:** 3

**Subject:** Drum Number 8 with visible hole and leakage

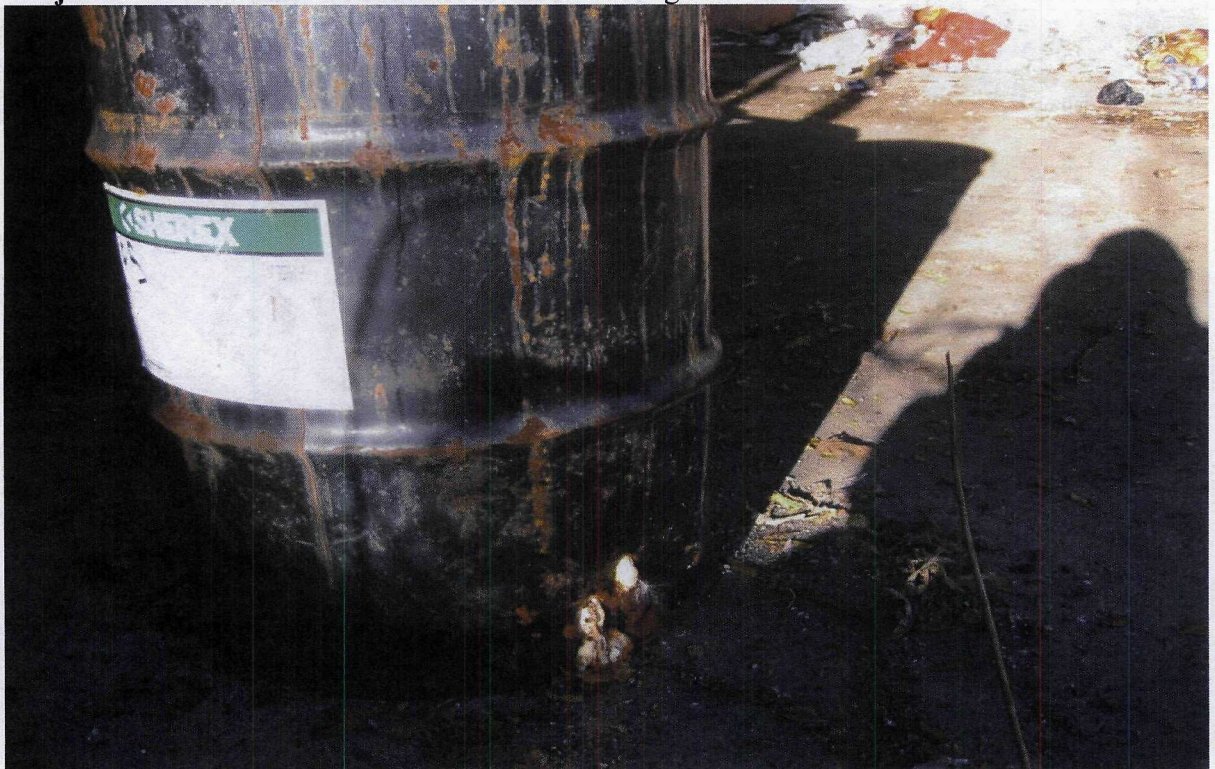
**Photo Number:** 4

**Subject:** Drum Number 15 with visible hole and leakage

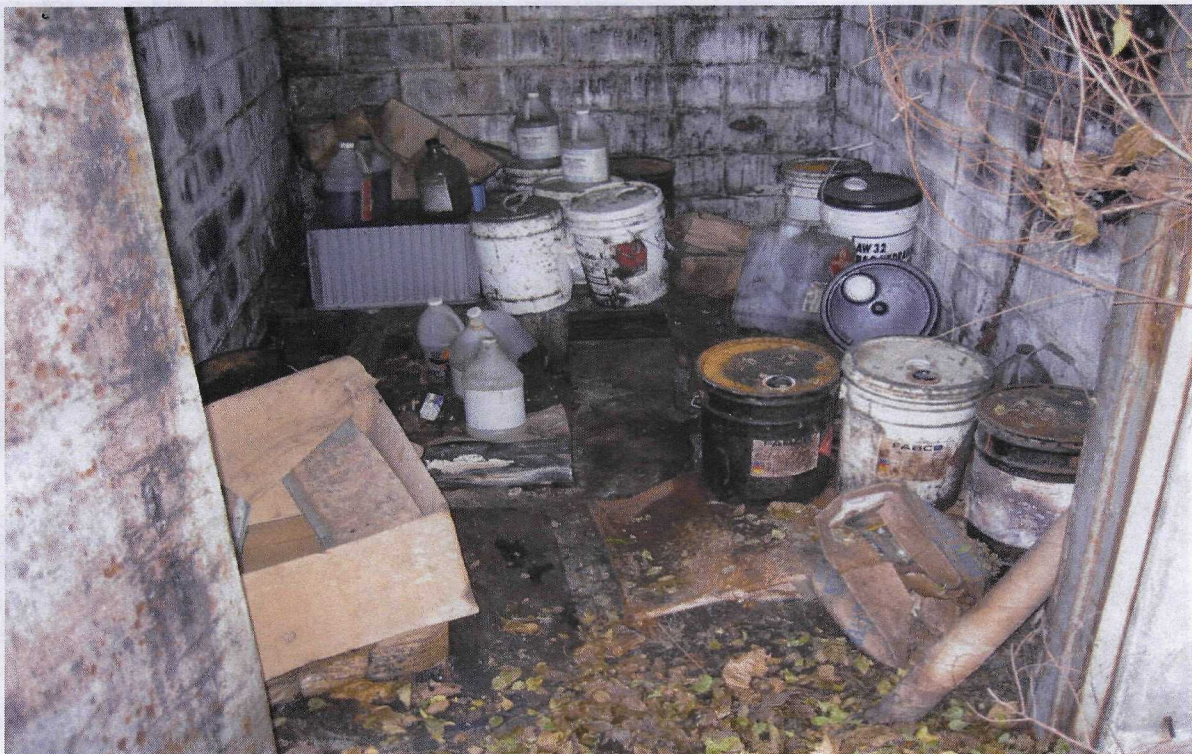
**Photo Number:** 5

**Subject:** Interior of equipment shed containing household hazardous waste and paint

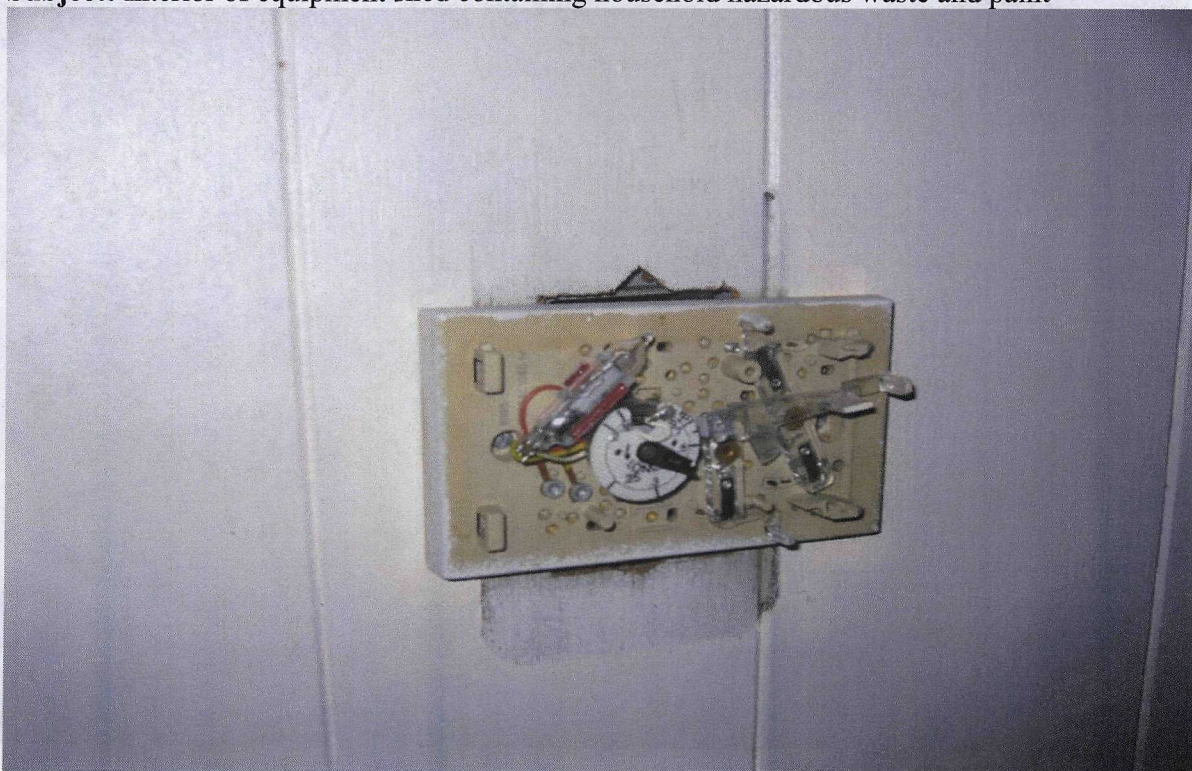
**Photo Number:** 6

**Subject:** Thermostat unit with mercury switch found in site building

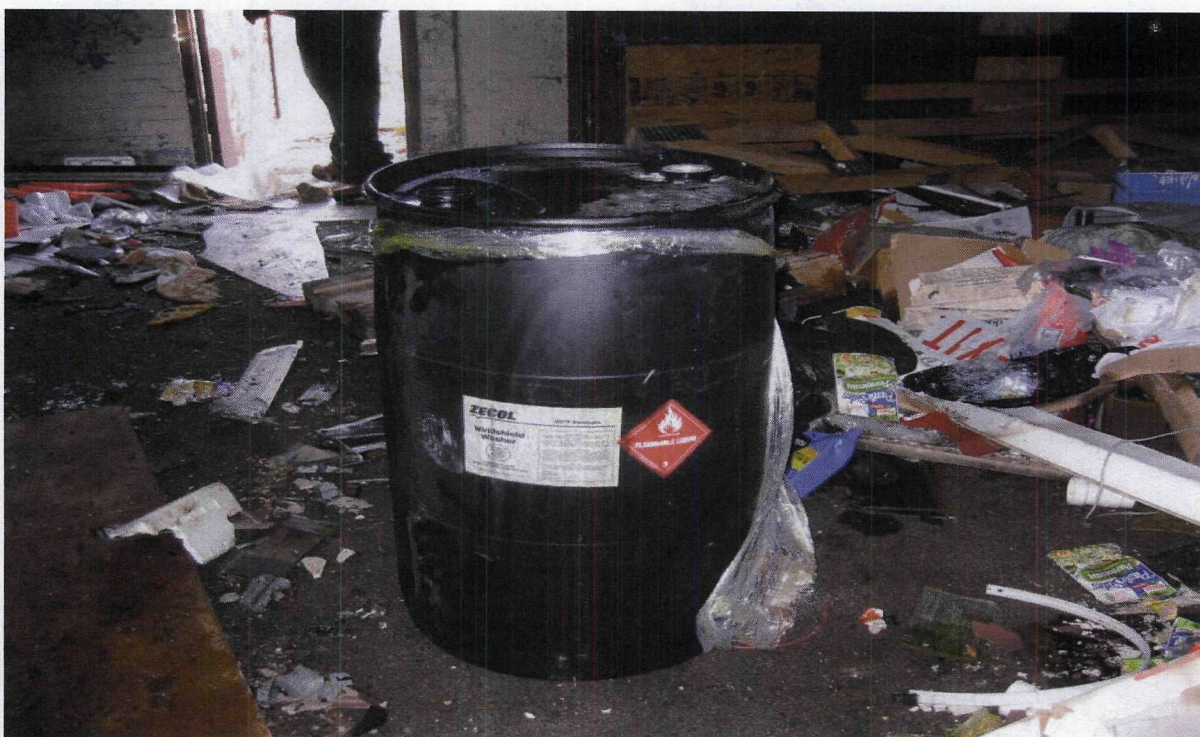
**Photo Number:** 7

**Subject:** Drum Number 26 found inside building near southeast door

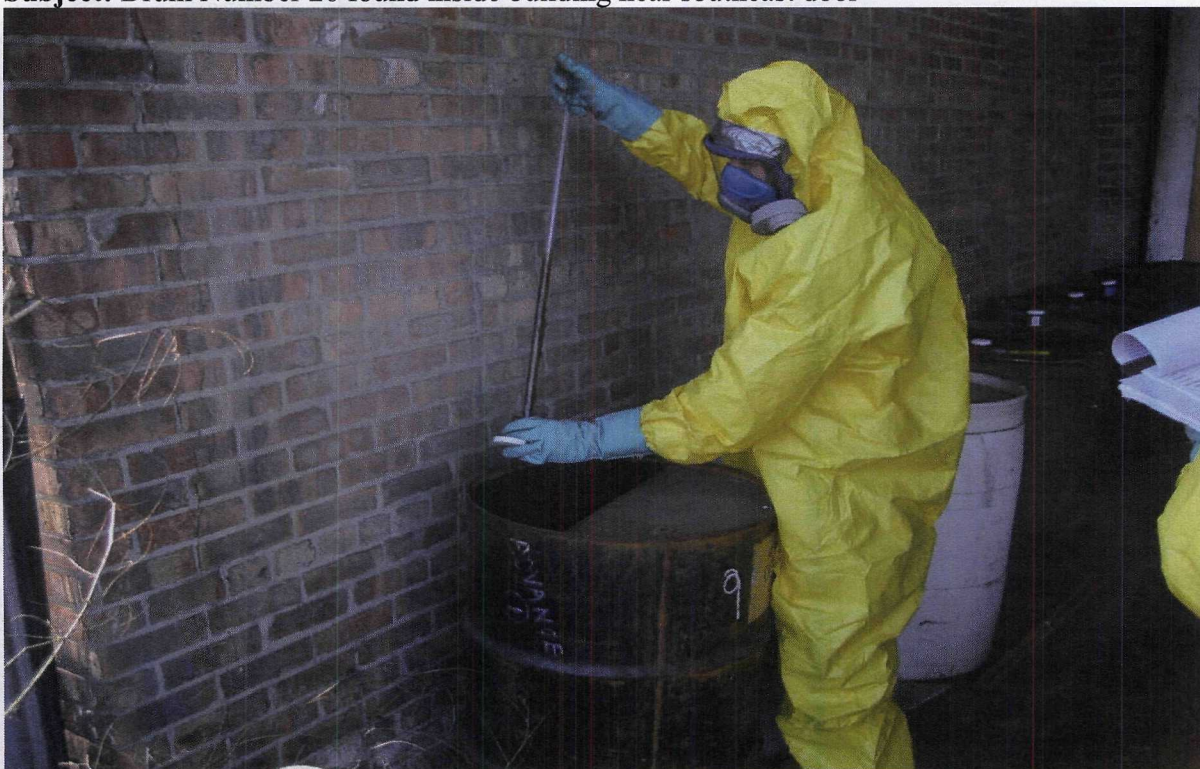
**Photo Number:** 8

**Subject:** Emergency and Rapid Response Services (ERRS) contractor sampling Drum Number 9 with glass extraction tube

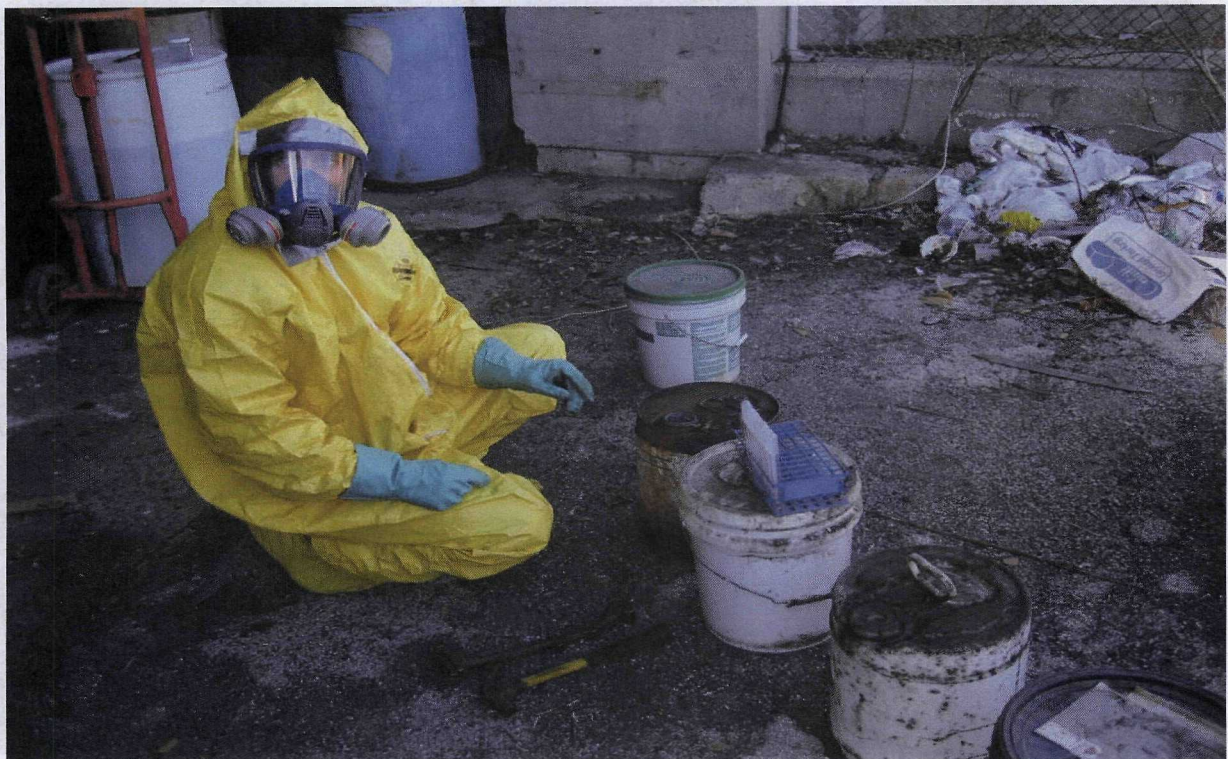
**Photo Number:** 9

**Subject:** ERRS contractor sampling small container of household waste

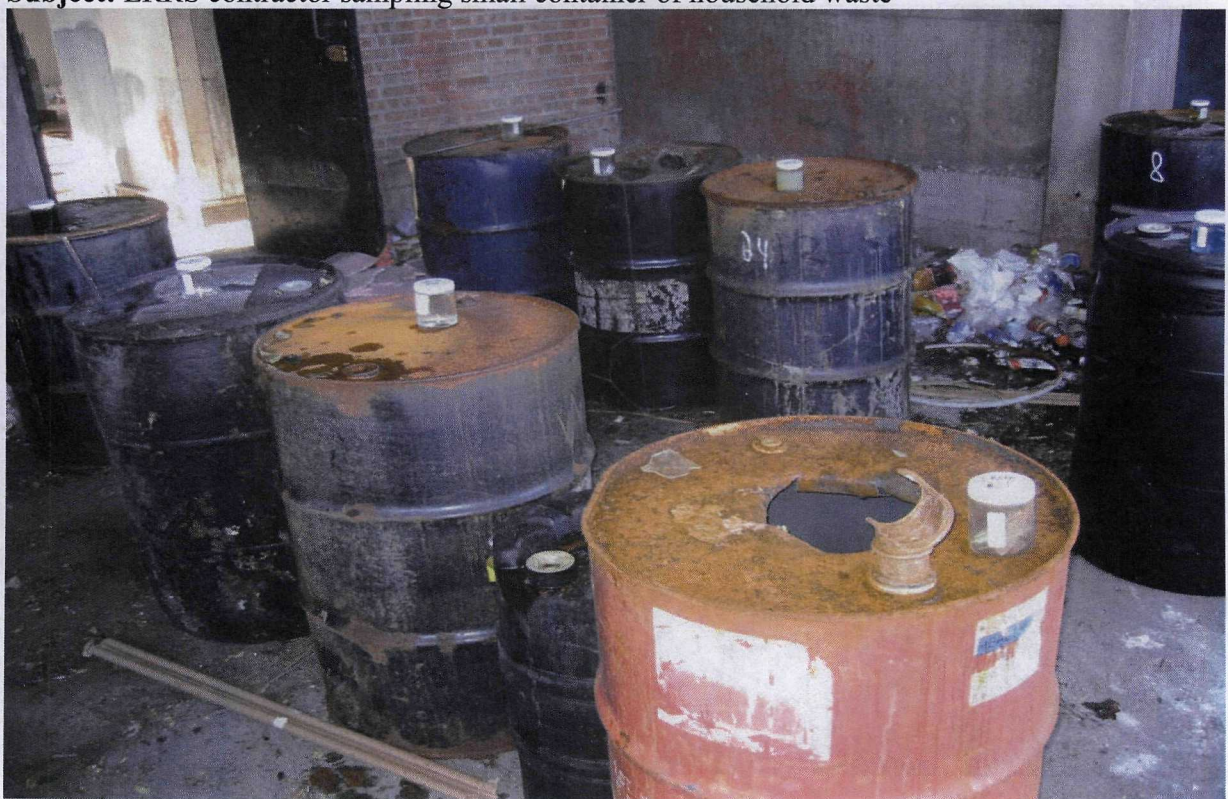
**Photo Number:** 10

**Subject:** Drums staged for sampling and temporary storage

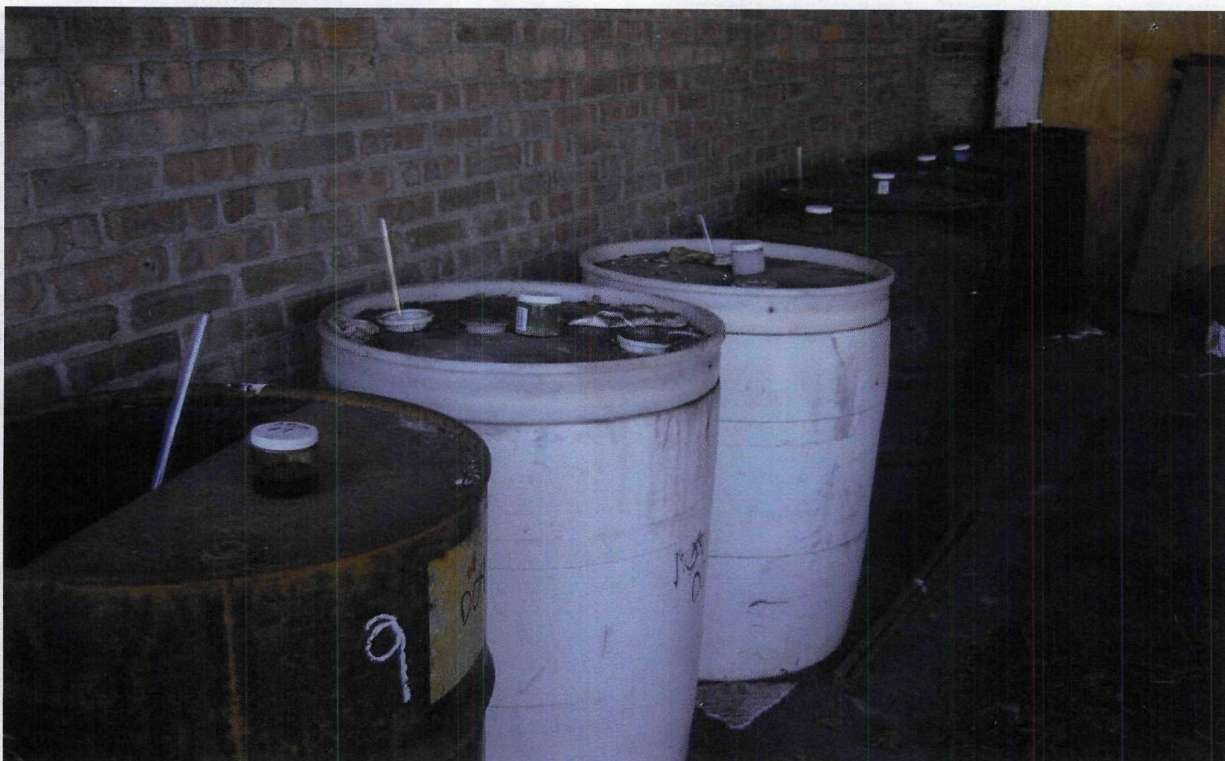
**Photo Number:** 11

**Subject:** Drums staged for sampling and temporary storage

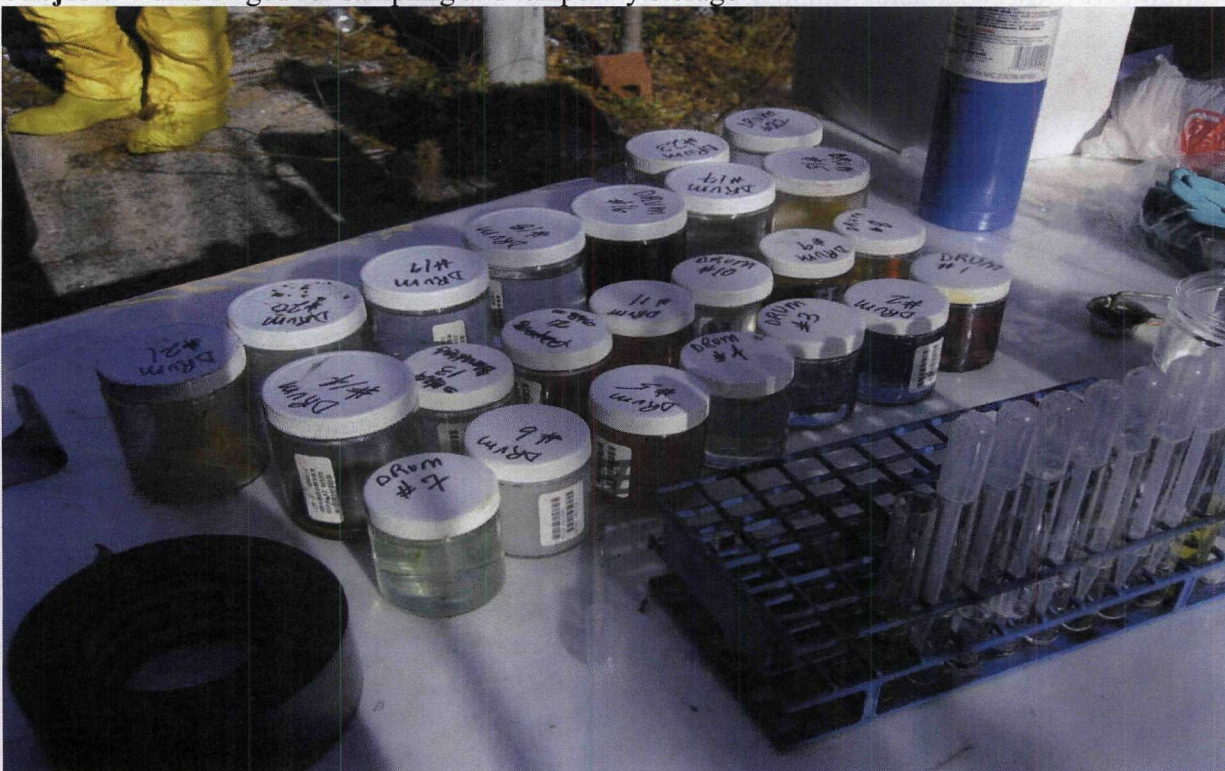
**Photo Number:** 12

**Subject:** Waste samples prepped for hazard categorization

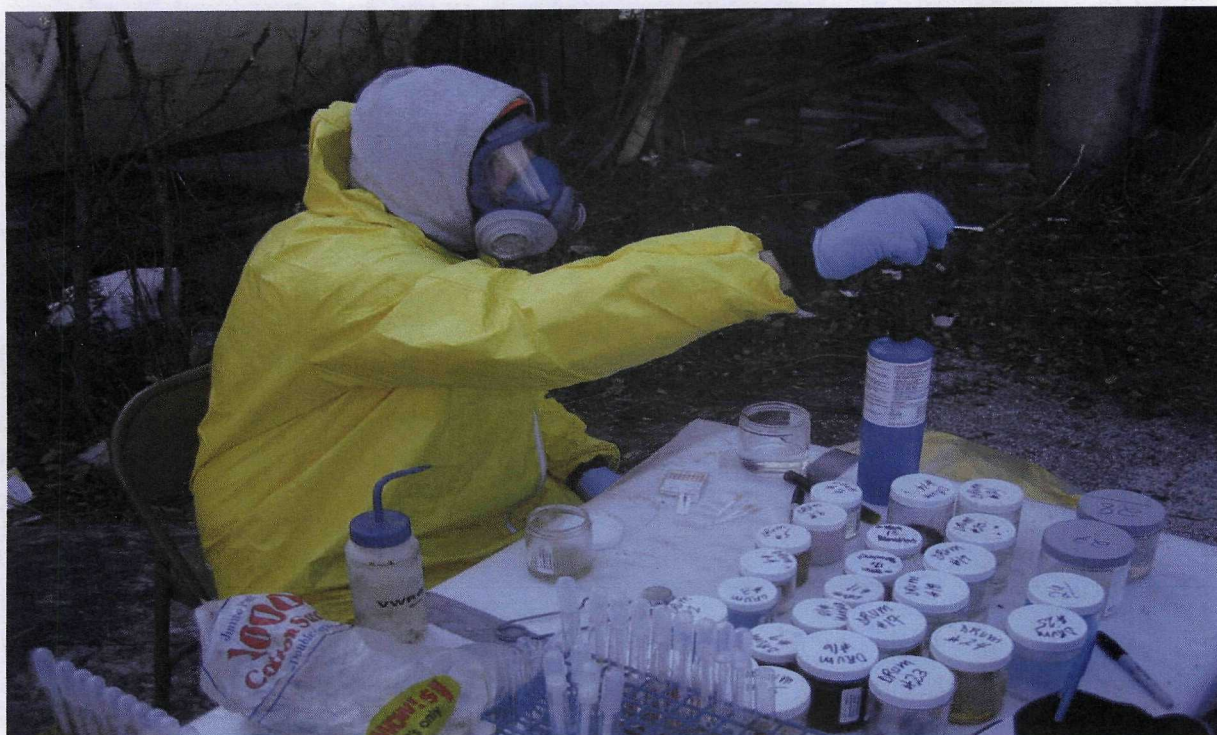
**Photo Number:** 13

**Subject:** ERRS contractor performing flammability test on waste samples

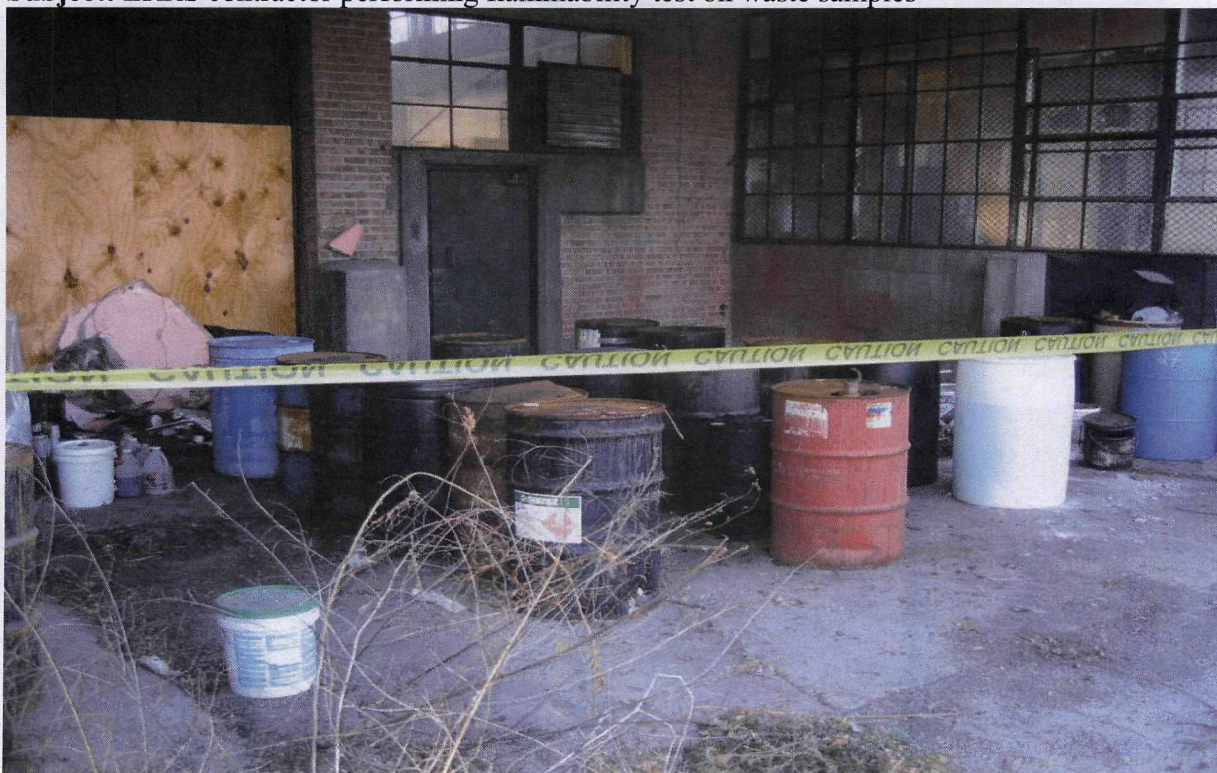
**Photo Number:** 14

**Subject:** Drums and waste staged for temporary storage in northeast courtyard behind caution tape
